Manhole Inspection Summary

Manhole # S290__044MH

Location Address: **901 W HAMBURG ST**

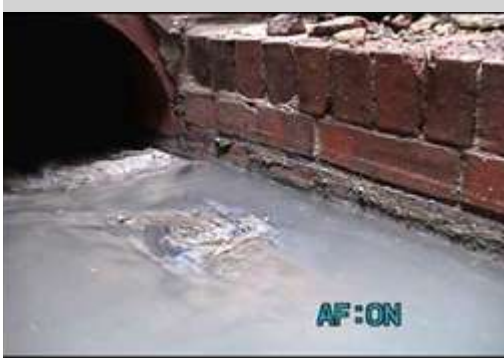
Miscellaneous

DEBRIS IN CHANNEL

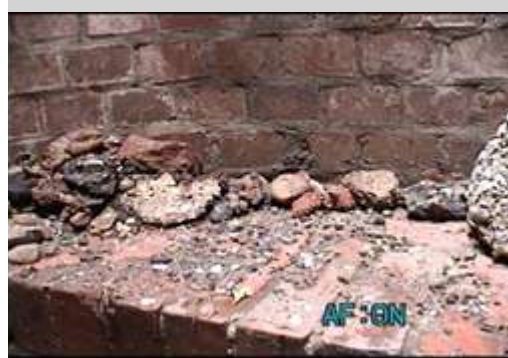
Miscellaneous

DEBRIS ON BENCH

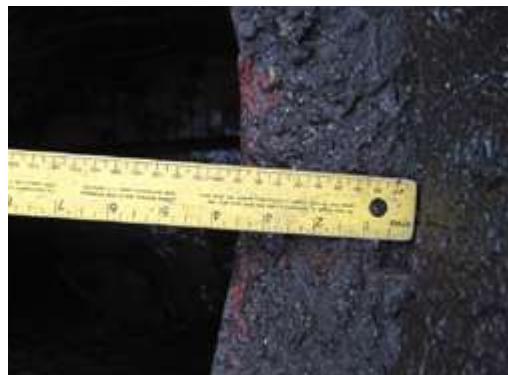
Defect 5

Offset: **4** (in.)

4 INCH OFFSET

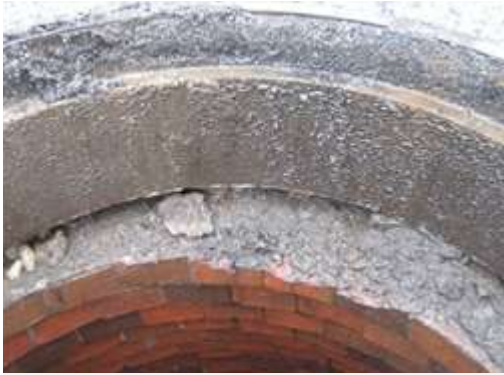
Defect 1

Condition: ☐ Sound ☐ Cracked ☐ Root Intrusion ☒ **Loose Brick** ☒ **Deteriorated**

Infiltration: ☐ None ☒ **Joint** ☐ Cracks ☒ **Mortar** ☐ Roots ☐ Wall

Frame & Chimney joint infiltration;
Chimney deterioration - loose brick &
missing mortar

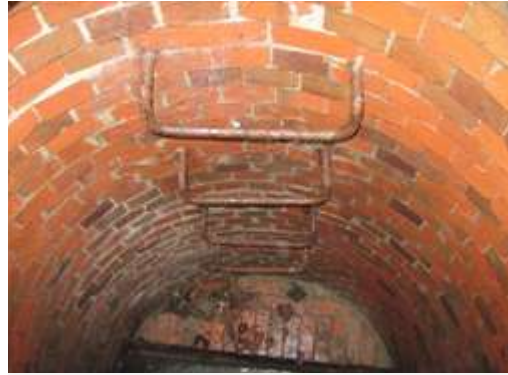
Defect 2

OXIDIZED RUNGS

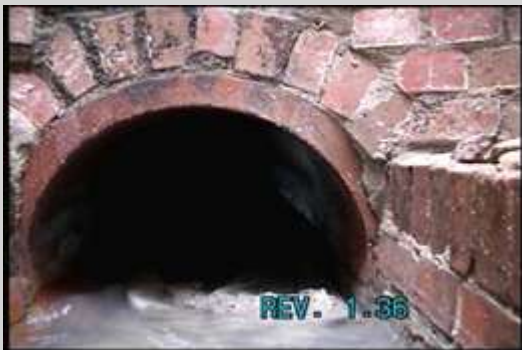
12 O'Clock Outflow

Pipe Height: **18** (in.) Rod and Bar (Angled)
Pipe Material: **Clay** ☐ Pipe Lined
Invert Depth: **9.34** (ft.) Flow Characteristics: **Slow**
Deposits: ☐ None ☐ Mud ☐ Sludge ☒ **Debris** ☐ Grease
Silt Depth: **1** (in.) Deposits Extent: **Light**
Infiltration: **None** Pipe Seal Cond: **Sound**
